EROSION CONTROL AT TRESTLE AN ENGINEERING STUDY CE 551 (U) AIR FORCE INST OF TECH WRIGHT-PATTERSON AFB OH M W KOCH MAY 84 AFIT/CI/NR-84-20T AD-A143 236 1/4 UNCLASSIFIED F/G 13/2 NL

EROSION CONTROL at 84 07 10 092 TRESTLE

MICHAEL W. KOCH, Capt., USAF Exersity of New Mexico

Submitted to DR JOHN B. CARNEY, Jr CE 552 23 April 1984

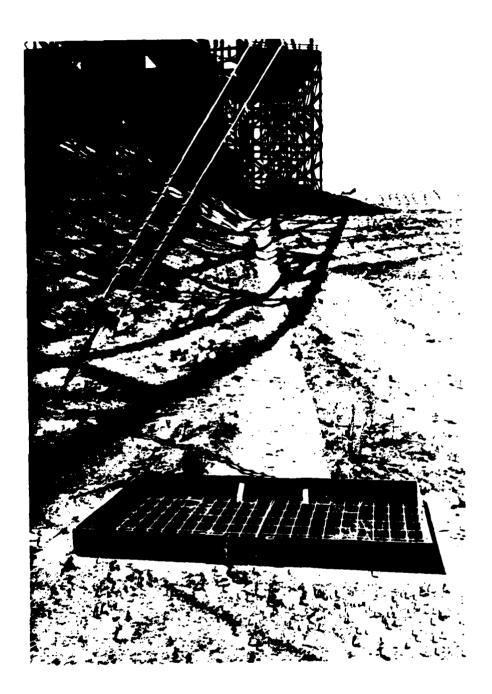
Fig. 2.2 Typical of the type chutes in use at the TRESTLE. This one, however, has a very moderate slope by comparison.

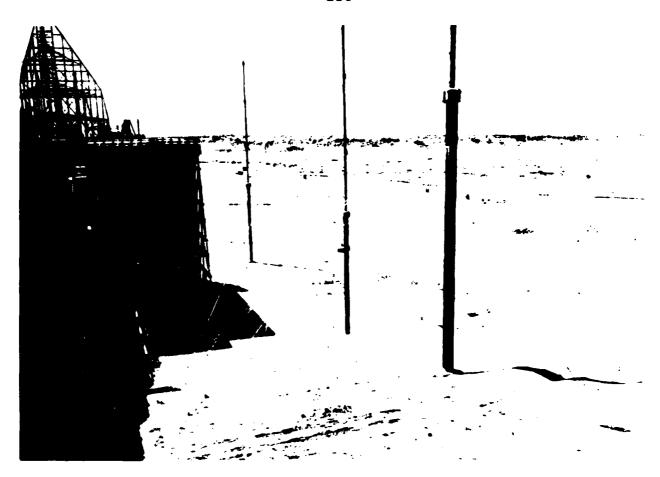
Fig. 4.9 The west side of the TRESTLE and bowl, looking south. Water flows to the right and south to be discharged through the pumps shown in the photo on the south side of the bottom of the Bowl. Note the access road on the high elevation. Also, rill erosion is very evident.

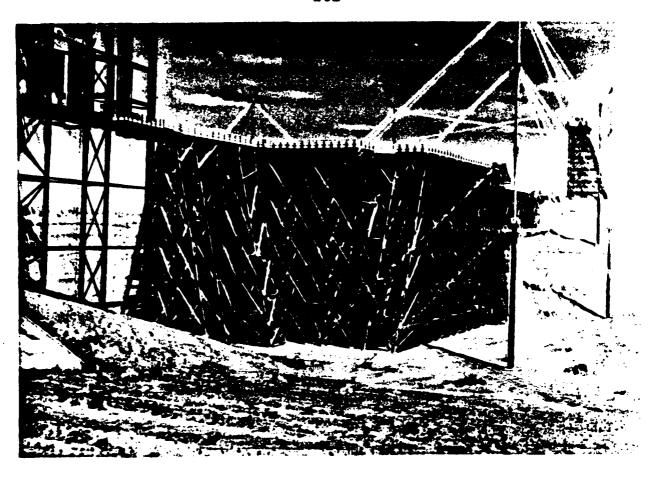
Fig. 4.11. The east side of the TRESTLE. Looking northwest..

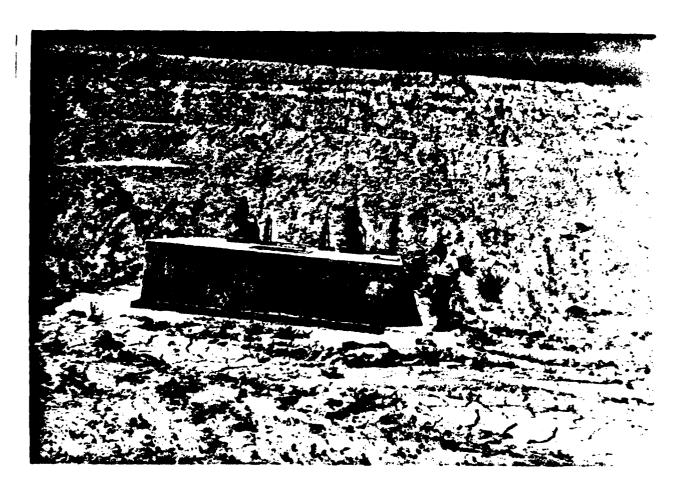
Fig. 4.19. The TRESTLE basin, southwest sector.
This gives some idea of the magnitude of the volume of soil migrating towards the sump pumps. More than 50 tons per year is estimated using the Universal Soil Loss Equation. Note the metal dam checks surrounding the grill work over the settling tank in front of the pumps. Also, a sizeable access port was cut into the top of the pump well housing to facilitate cleaning the well. (See sketch, Fig. 4.20).

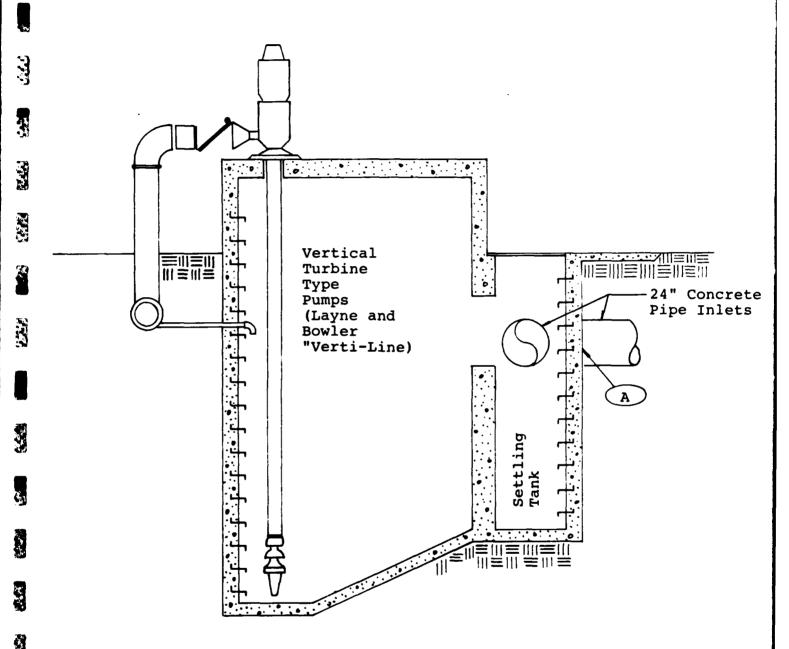
Fig. 4.20 STORM DRAINAGE PUMP & TANK SECTION Scale: \(\frac{1}{3}\)"=1'-0"
